syngo.via RT Image Suite
with *syngo.via* VB30 and *syngo.via* VB40 software
with licence for patient marking with external lasers
(technical name of the license:
"CT RT IMAGE SUITE PAT MARK")

Customer Safety Advisory Notice SY051/20/S

**SOMATOM go. CT Scanners with
syngo.RT Image Suite**
with *syngo.CT* VA20A, *syngo.CT* VA30A
with licence for patient marking with external lasers
(technical name of the license:
"CT RT IMAGE SUITE PAT MARK")

Subject: Incorrect calibration offset between CT central image plane and external lasers after update/upgrade potentially resulting in an unprecise cancer treatment

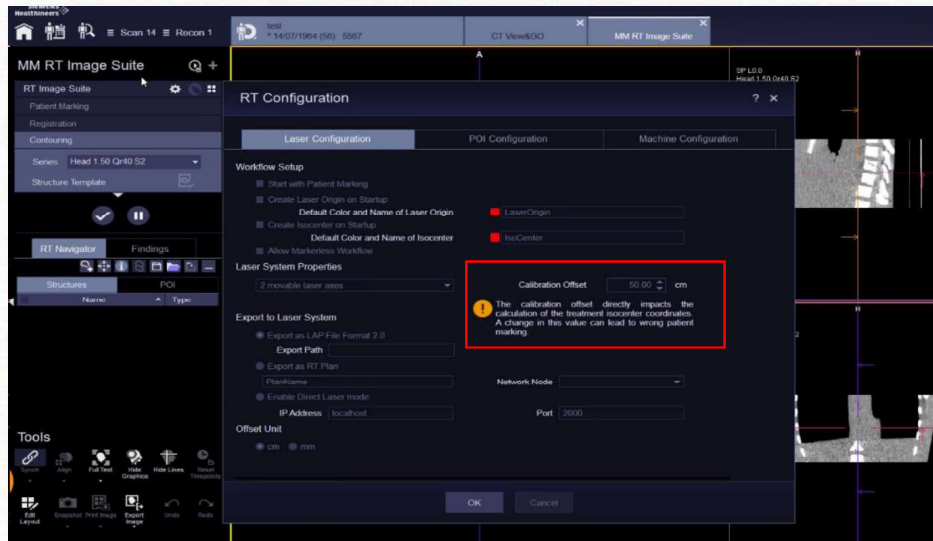
The calibration offset between the central CT image plane and the external RT lasers has been set automatically to the factory default of 50.00 cm, if your *syngo.via* RT Image Suite has been updated or upgraded to one of the following software versions:
- *syngo.CT* VA20A to *syngo.CT* VA30A
- from any lower *syngo.via* SW-version to *syngo.via* VB40

Figure 2: MM RT Image Suite Configuration dialog with the marked parameter

Please update the calibration offset in the MM RT Image Suite Configuration dialog accordingly as shown below in Figure 2. Details of this procedure are documented in Chapter 13.2 (Laser configuration) of your user manual.
