Nujno varnostno obvestilo

Sistemska napaka pri preverjanju veljavnosti podatkov v programski opremi Intellis™ Posodobitev programske opreme modela A710 na različico 1.3.130 Posodobitev programske opreme

December 2020

Referenca družbe Medtronic: FA949

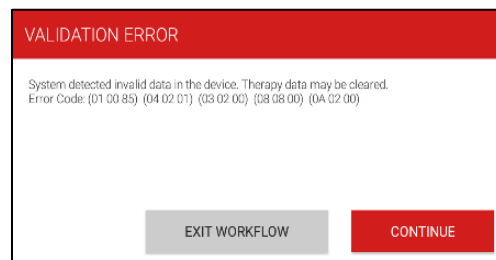
Družba Medtronic je med januarjem 2020 in 24. novembrom 2020 prejela štirinajst (14) poročil, v katerih so uporabniki prijavili to napako preverjanja veljavnosti (Slika 1) v različici 1.3.80 programske opreme Intellis A710 programatorja za zdravnika CT900, ki ji je sledila sistemska napaka (Slika 2 **Error! Reference source not found.**), in navedli, da programske posodobitve stimulatorja ni bilo mogoče dokončati. Po preiskavi je bilo ugotovljeno, da je na določeni lokaciji pomnilnika stimulatorja prišlo do poškodbe podatkov in da programska oprema Intellis A710 različice 1.3.80 ni počistila poškodovanih podatkov, kot je bila zasnovana, zaradi česar je prišlo do sistemske napake. Ta sistemska napaka ni pogost dogodek, poročana stopnja pogostnosti pa je nižja od 1 na 10.000.

Ta težava je prepoznana in se pojavi v kliničnem okolju, ko je bolnik v oskrbi zdravstvenega delavca. Če se napaka VALIDATION ERROR (Napaka preverjanja veljavnosti) (kot je prikazano) s kodo napake (01 00 85) (04 02 01) (03 02 00) (08 08 00) (0A 02 00) prikaže, **preden** namestite najnovjšo različico 1.3.130 programske opreme Intellis A710, izberite možnost **CONTINUE** (Nadaljuj). Če izberete **EXIT WORKFLOW** (Izhod iz poteka dela), znova vzpostavite komunikacijo in pri prikazu napake VALIDATION ERROR (Napaka preverjanja veljavnosti) (slika 1) izberite **CONTINUE** (Nadaljuj).

Slika 1: Poziv napake preverjanja veljavnosti

V programator za zdravnika CT900 skladno z zagotovljenimi navodili prenesite najnovjšo posodobitev programske opreme Intellis A710, različico 1.3.130.

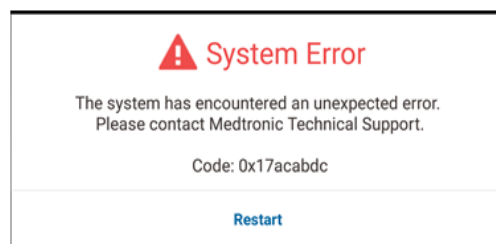
Slika 2: Poziv sistemske napake

Ko izberete možnost **CONTINUE** (Nadaljuj) in se vam prikaže **System Error** (Sistemska napaka) (slika 2), se za pomoč pri prenosu najnovjše različice 1.3.130 programske opreme Intellis A710 obrnite na predstavnika družbe Medtronic. Ko prenesete najnovjšo različico 1.3.130 programske opreme Intellis, znova vzpostavite komunikacijo in izberite **CONTINUE** (Nadaljuj), da odpravite to težavo.
