Customer Safety Information (CSI) for Field Safety Corrective Action: AX014/20/S

Subject: Field Safety Notice for: Exchange of a printed circuit board (“main control D80” with revision less than 04) which is included in certain Cios Spin & Cios Alpha systems.

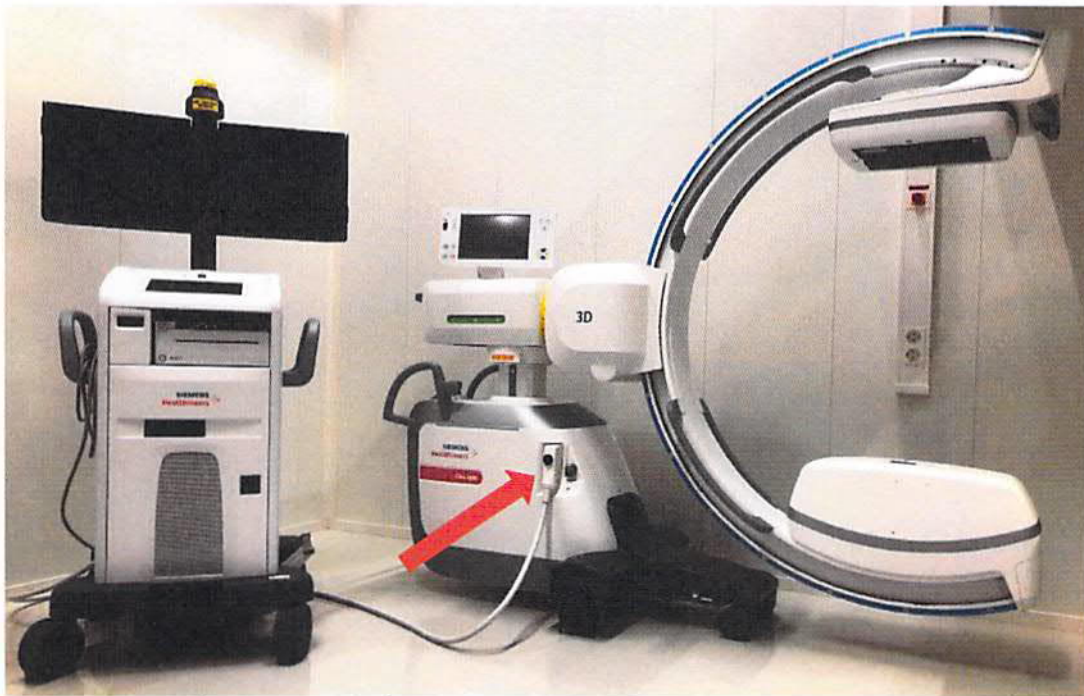
Our Cios systems offer a “hot plugging” feature between trolley and main unit (c-arm). The “hot plugging” feature enables the clinical user to plug/unplug the X10 connector of the main cable (please refer to figure 1 below) at any time during clinical session, provided that the system is electrically connected and powered on. In very few cases the “hot plugging” feature could cause an electrical malfunction on the main control D80 of the generator which is part of the main unit (c-arm).

figure 1: example of X10 connector with main cable, connected to Cios Spin c-arm

The subject was identified during a demo session when application engineer wanted to perform the “hot plugging” feature of a Cios Alpha VA30 system. The root cause is a design flaw in the component main control D80 with revision less than 04.

A service engineer will replace the main control D80 of your affected system by a revised main control.
