| Welch Allyn, Inc. 4341 State Street Road Skaneateles Falls, NY 13153 USA | URGENT: Field Safety Notice | 2021-07-001-MKE-005 |

ELI280, MLBUR280 and BUR280 Electrocardiographs

ELI280 resting electrocardiograph - Patient mismatch/Software Upgrade

FSCA-identifier: 2021-07-001-MKE-005

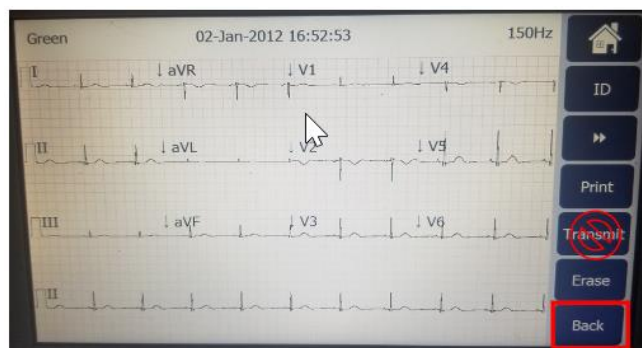
Figure.1

1. An ECG is acquired for Patient A and stored to the cardiograph.
2. An ECG is acquired for Patient B and stored to the cardiograph.
3. The ECG record associated with Patient A is retrieved from memory and any Patient Demographic information is edited.
4. After editing, the "Resting ECG" screen is presented as shown below. Figure 1
5. Pressing the TRANSMIT button from this screen (following any Patient Demographic edit) will transmit an ECG record other than for patient A. (see figure 2, which shows the Resting ECG screen).

If an ECG record is retrieved from the patient directory for a Patient Demographic edit to be performed, once the information has been edited and the screen above (Fig 1) is presented, do not press the transmit button. Instead, press the BACK button which will SAVE the changes to memory and present the user with the following screen, where the SYNC button can be used to transmit the desired record to the configured destination.

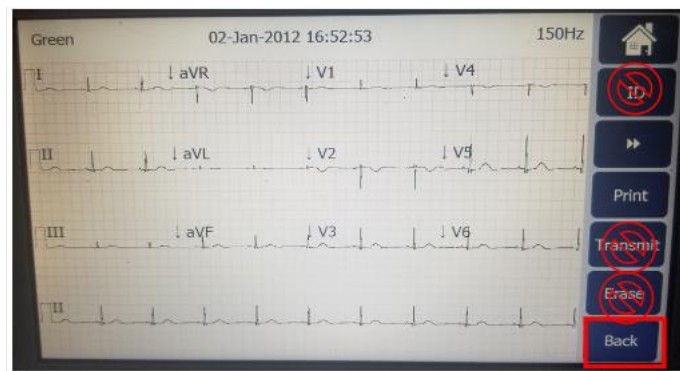
Figure.3

1. An ECG is acquired for Patient A and stored to the cardiograph.
2. An ECG is acquired for Patient B and stored to the cardiograph.
3. The ECG record associated with Patient A is retrieved from memory and ID information is edited.
4. After editing, the “Resting ECG” screen is presented as shown in Figure 3.
5. The user decides to make another ID Edit without leaving the “Resting ECG” screen and presses the “ID” button - Figure 3.

6. After the second edit is performed, the “Resting ECG” screen is once again presented as shown above.
7. Pressing the TRANSMIT button from this screen (following two ID edits in a row as defined above) will transmit an ECG record with the patient demographics

from Patient A and the ECG record for Patient B, this “hybrid” record is then stored in the cardiograph as second record with patient A demographics, and Patient B will no longer be listed in the directory.
