UPDATE
URGENT FIELD SAFETY NOTICE
MEDICAL DEVICE CORRECTION

MAQUET CARDIOSAVE hybrid and MAQUET CARDIOSAVE rescue

Product Code/Part Number:	0998-XX-0800-XX
Distributed Affected Lot Number:	All
Distribution Dates:	Since March 6, 2012

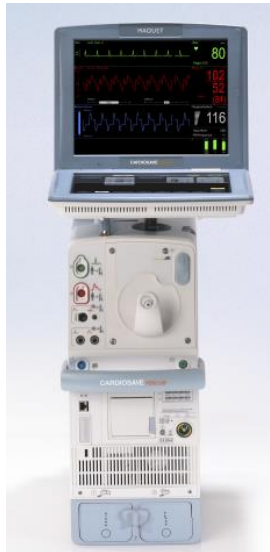
Figure 4: Cardiosave in Transport Configuration

Cardiosave Rescue (Figure 4)

An unexpected shutdown upon battery removal cannot occur for Cardiosave Rescue.
