Field Safety Notice

2019-12-20 | REF-MSA-2019-002-IU |

Subject: Broken circlip on Hanaulux sterilizable handle hub

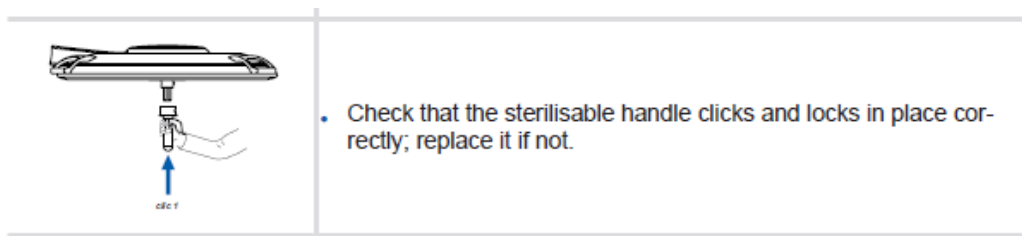
NU_HLED_01601EN08 : Chapter 10 Maintenance page 38

1. Verify that the locking mechanism works correctly before use

2. If the mechanism does not work or lock correctly, please contact a Getinge representative or Maquet SAS' International Technical Service
3. Only use the recommended cleaning materials and cleaning protocols as follow :
