Security information

Product: PL730SU

Product name: CAIMAN Vessel sealing instrument, 240 mm working length, diameter 12 mm, muzzle length: 50 mm, sterile, disposable

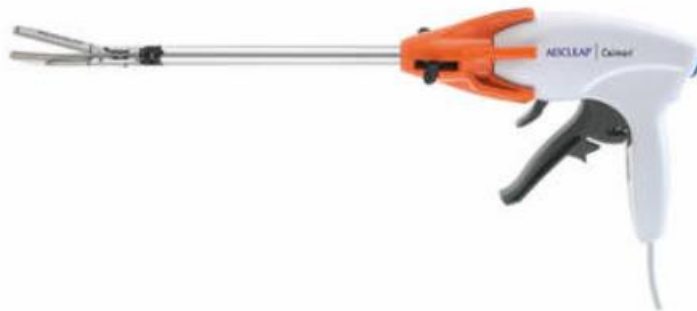
Fig. 1: Position of the affected pin.

Aesculap AG received customer feedback that a pin can loosen and fall out of the instrument for the mouth pieces of PL730SU, CAIMAN vascular sealing instrument (Figure 1). The error could be limited to the mentioned product.

The pin potentially dissolves only with a fully opened mouth part. A loosened pin results in the function of the instrument no longer being given. If the pin loosens during application, this can be noticed by the missing function of the instrument. Instruments that did not show any abnormalities during clinical use are not affected by the market measure. The above error pattern may also occur during transport. The pin lying loosely in the transparent packaging can be detected.

After our research, you have received articles of the affected product. Please check if such products are in your facility in the application.

If you have been able to locate an affected product in your organization, please send the product to:
