IMPORTANT SAFETY INFORMATION

Reference: CAP-19-0115

- Multifunction Electrodes, compatible with MEDUCORE Standard², for adults, REF: WM 45418
- Multifunction Electrodes, compatible with MEDUCORE Standard and MEDUCORE Easy, for adults, REF: WM 40116

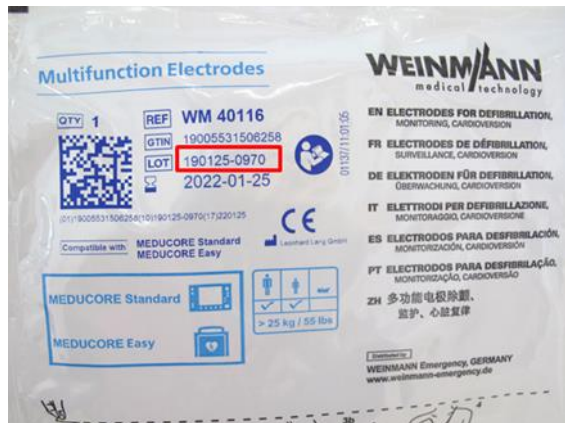
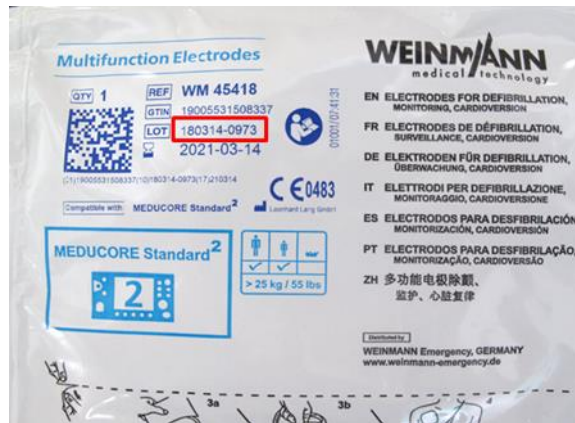
Identification of the Lot Numbers on the Product Packaging

The lot number is printed on each pouch and marked with LOT. Here highlighted in red as an example.
