**Field Safety Notice**  
**RadiForce RX360 and GX560 Abnormal image displayed**

## Field Safety Notice (FSN)

### RadiForce GX560 and RX360 Abnormal image displayed

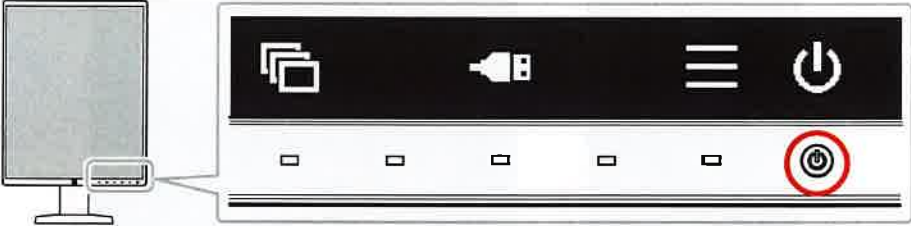
<b>2. Reason for Field Safety Corrective Action (FSCA)*</b>	
2.	<p><b>1. Description of the product problem*</b></p> <p>The following marble pattern fairly infrequently appears when one of the following conditions are met.</p> <ul style="list-style-type: none"> <li>● Turning the power off and on by touching power switch in front of the monitor</li> </ul>

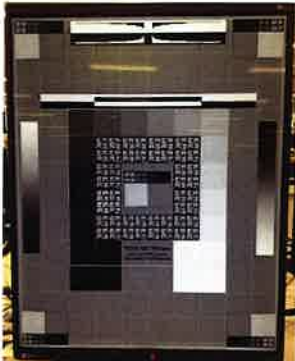
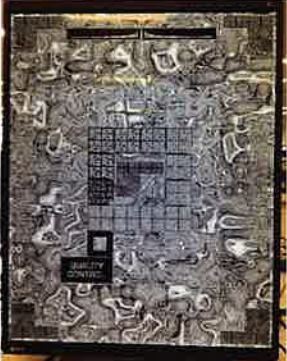
<p>Normal</p> </div> <div style="text-align: center;">

<p>Abnormal Display</p> </div> <div style="text-align: center;"> <p>RadiForce RX360</p>

3. Type of Action to mitigate the risk*		
3.	<p><b>1. Action To Be Taken by the User*</b></p> <p>If you see abnormal display, please stop using your monitor and eliminate the phenomenon by turning the monitor's main power off and on again.</p> <div style="text-align: center;">

3.	3. Is customer reply required? *	No
3.	<p><b>4. Action Being Taken by the Manufacturer</b></p> <p>On-site device modification/inspection and Software upgrade</p> <p>A firmware update is now being prepared to solve this issue. The correction will consist of a software (firmware) upgrade and will be provided free of charge to all devices affected by this issue. An EIZO representative will contact customers with affected devices to arrange for installation of the upgrade.</p>

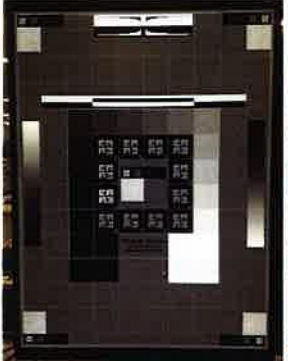
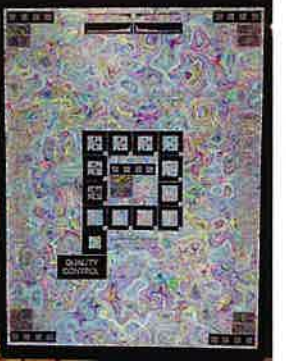
<p>Normal</p> </div> <div style="text-align: center;">

<p>Abnormal display</p> </div> </div>

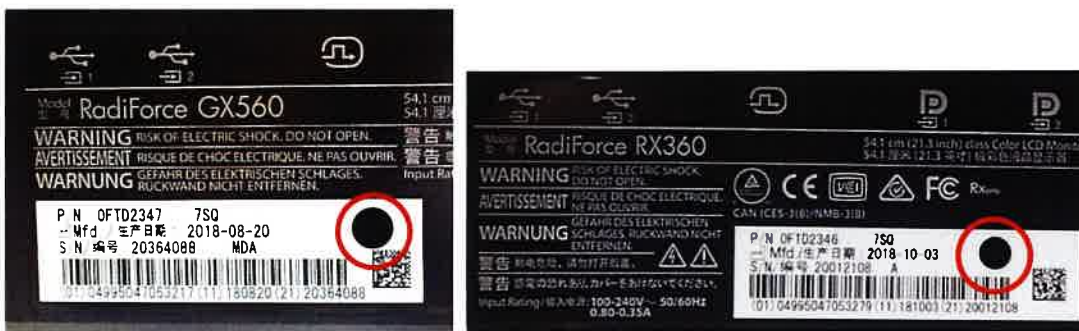
Black Dot Mark

<sup>1</sup> Monitor with a black dot mark on the nameplate are unaffected by this issue (see below)

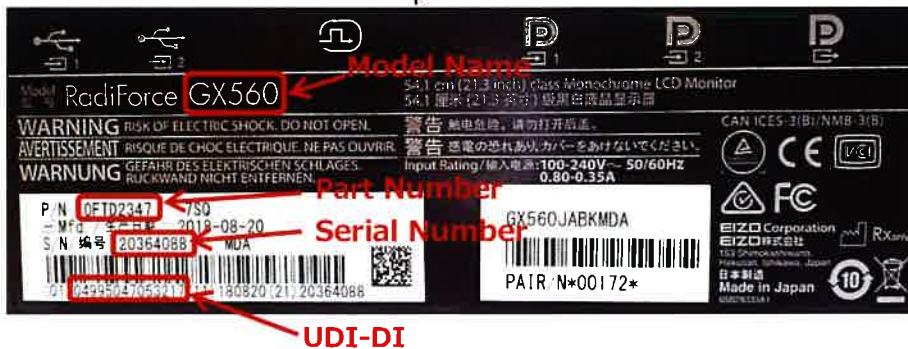
**RadiForce GX560 Name Plate Sample**

A) Referring to the name plate located on the back of the monitor.

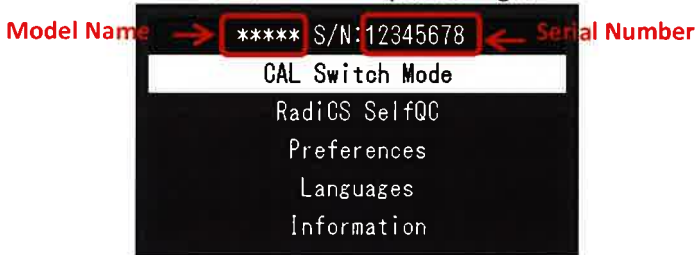
- ii. Select

from the Operation guide. The Setting menu appears.

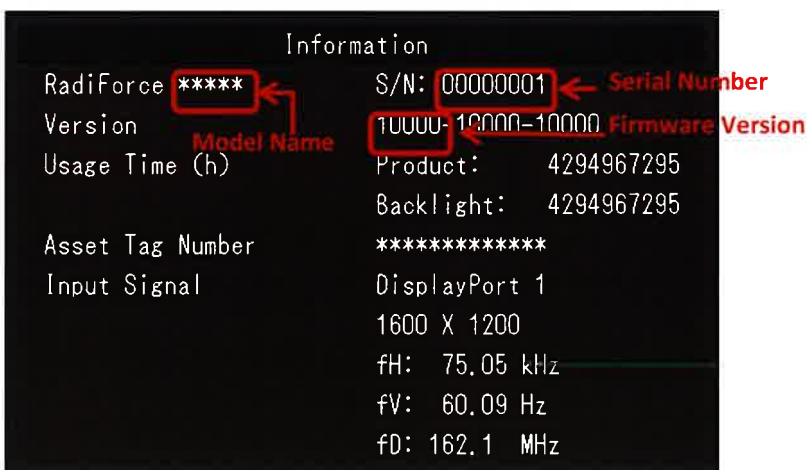
- iii. Select "Information" from the Setting menu, then select . Model name, serial number and firmware version are displayed.
