**Urgent Field Safety Notice**  
**HLS Set 7050 & HLS Set 5050**

**Urgent Field Safety Notice (FSN)**  
**HLS Set 7050 & HLS Set 5050**  
**Risk addressed by FSN**

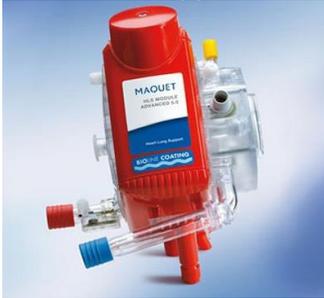
<b>1. Information on Affected Devices*</b>	
<b>1</b>	<p><b>1. Device Type(s)*</b></p> <p>The HLS Set Advanced (see figure 1) is intended for use in an extracorporeal circulation for cardiac support and/ or pulmonary support.</p>

<p>Figure 1: HLS Module Advanced</p>
<b>1</b>	<p><b>2. Commercial name(s)</b></p> <p>BE-HLS 7050 (part number 701069073)            BE-HLS 5050 (part number 701069076)            BO-HLS 7050 (part number 701069083)</p> <p>BE-HLS 7050 USA (part number 701069078)            BE-HLS 5050 USA (part number 701069077)</p> <p>BO-HLS 7050 CA (part number 701069065)            BEQ-HLS 5050 CA (part number 701069068)</p>
<b>1</b>	<p><b>3. Unique Device Identifier(s) (UDI-DI)</b></p> <p>04058863005744 (BE-HLS 7050, part number 701069073)            04058863078298 (BE-HLS 5050, part number 701069076)            04058863020082 (BO-HLS 7050, part number 701069083)</p> <p>04058863080383 (BE-HLS 7050 USA, part number 701069078)            04058863076355 (BE-HLS 5050 USA, part number 701069077)</p> <p>04058863300238 (BO-HLS 7050 CA, part number 701069065)            04058863304625 (BEQ-HLS 5050 CA, part number 701069068)</p>

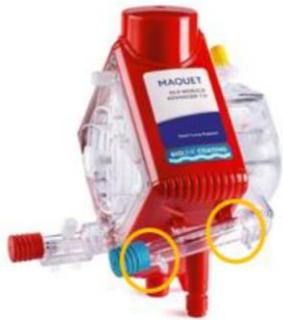
The damages are caused by the tabs of the venous probe holder within the packaging (figure 2). Consequently, depending on the orientation of the Tyvek cover on HLS tray, holes can appear either on the left or right side of the Tyvek (figure 3 and 4), which corresponds to the position of the venous probe holder.

Figure 2: both tabs of the venous probe holder within HLS Module

1. The damages can only occur if the device is dropped **upside down** from **above of 0,8 meter** height
2. If the device is dropped upside down from 0,8 meter height, the packaging is reversible deformed by the impact force, which leads to movement of oxygenator relative towards to Tyvek cover and pierce the Tyvek primary packaging, creating one or two punch holes with the size of 6mm to 16mm .The damages of the primary packaging can occur either on the left or the right side, depending on the orientation of Tyvek cover.  
Loss of product sterility.

2	<p style="text-align: center;"><b>3. Background on Issue</b></p> <p>Maquet Cardiopulmonary got aware of this topic by customer complaints where it was reported, that the primary packaging was observed be damaged during unpacking of the device.</p> <p style="text-align: center;">-</p> <p><b>Root Causes:</b></p> <ul style="list-style-type: none"> <li>- Outer packaging (tertiary packaging) used for transportation of HLS Sets from the SSU to the customer (especially in USA), lack appropriate transport handling marks, clearly highlighting the correct upright position of the delivered product. In USA outer packaging (tertiary packaging) is used for all HLS Sets, this is not always the case for rest of the world. The number of complaints per sold devices coming from USA correlates with that root cause.</li> </ul> <p>The absence of labeling on the outer packaging increases the probability of rough handling of the devices. The missing directional labels can lead to an overhead transportation. If the device is transported upside down and is dropped from over 0,8 meters, it may get damaged. The directional labels are part of the risk mitigation file as a risk mitigation measure. The use of outer packaging without application of similar labels leads to an ineffective risk mitigation measure.</p> <ul style="list-style-type: none"> <li>- The current packaging is not designed to withstand inappropriate handling during transport (e.g. box is dropped upside down from carrying height (approximately 0,8 meters)).</li> </ul> <p><b>Actions to mitigate the risk:</b></p> <ol style="list-style-type: none"> <li>1. Reactivation of ineffective risk mitigation measure. Application transportation conditions labeling to outer packaging. – Implemented</li> </ol> <p><b>Actions to improve detectability:</b></p> <ol style="list-style-type: none"> <li>2. Application of an inspection instruction to every HLS set to show the location of possible damages resulting from this nonconformity. Inform all customers regarding the possible damages on the HLS Set primary packaging.</li> </ol> <p><b>Further Actions to remove unknown improper handling from the transportation.</b></p> <ol style="list-style-type: none"> <li>3. Specify the logistics conditions <ul style="list-style-type: none"> <li>o Restrict parcel shipment</li> <li>o Allow only following shipment from Getinge distribution centers: <ul style="list-style-type: none"> <li>• On pallet with proper fixation, preventing upside down transport</li> <li>• With sensitive freight carrier and instructed driver how to handle the HLS Set.</li> </ul> </li> </ul> </li> </ol> <p><b>Packaging design with inherent safety</b></p> <ol style="list-style-type: none"> <li>4. Development of a design solution which can withstand the upside down drop from 0,8 meters height. Currently not available.</li> </ol> <p>Actions 2 and 3 will be obsoleted with the implementation of inherent safe packaging design.</p> <p>With implemented actions 1-3 the product is considered as <b>safe</b>.</p>

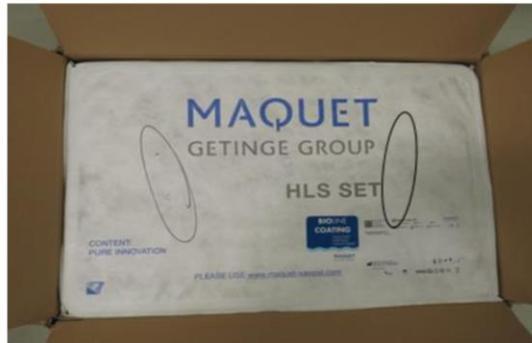
Figure 3: position of potential damages either on left or right side, depending on position of HLS Module in the package

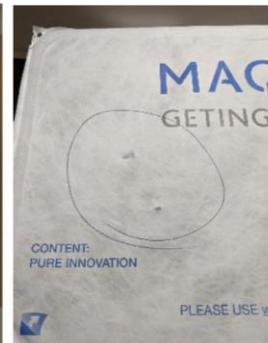
<p><b>2 Reason for Field Safety Corrective Action (FSCA)*</b></p>	
2	<p><b>1. Description of the product problem*</b></p> <p>The HLS Set Advanced is intended for use in an extracorporeal circulation for cardiac support and/ or pulmonary support. Maquet Cardiopulmonary GmbH (MCP) has received customer complaints of damage to the primary packaging of the HLS Set Advanced.</p> <p>In all customer complaints it was reported that the Tyvek cover was damaged. The appearance of the packaging failure can be hole(s) in the Tyvek.</p>

Figure 4: example of holes in the Tyvek cover

All reported complaints are connected identification of damages in primary packaging during opening of the device. All identified holes coming either from the complaint devices or internal investigations have the size between 5 mm and 20 mm. This indicates a high rate of detection.

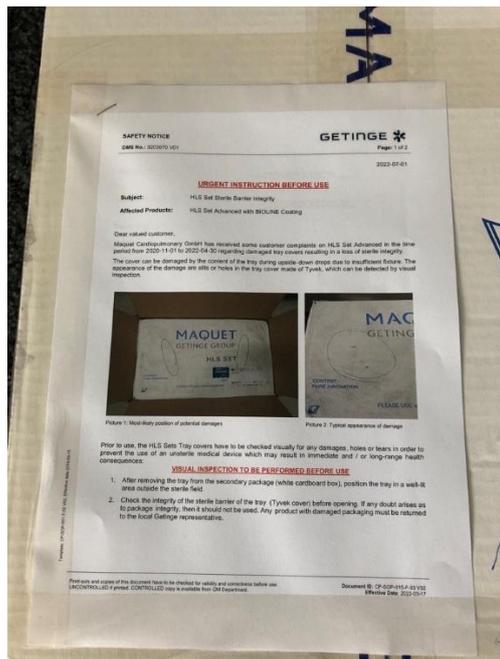
Figure 7: Attachment affixed by SSU to every white box

- Please inform all affected end customers about this field action by sending the Field Safety Notice for Customer with related enclosed documents.
- Please attach the provided Field Safety Notice for Customer to all affected products in your stock, prior to sending them to the end customers. If this was already done by your Getinge Representative (see figure 7), you do not need to do it.

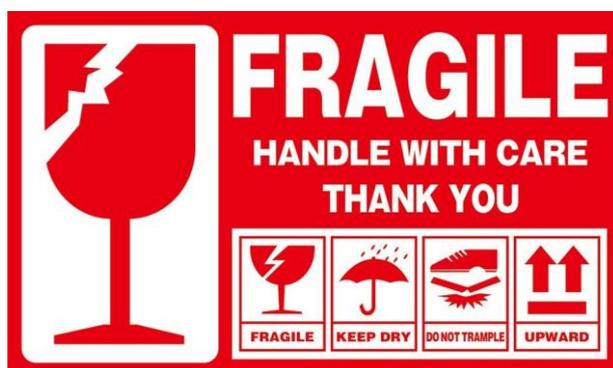
Figure 8: Example of transport label for forwarder

- Please affix highly visible the transport label in the outer side of each shipment box prior to transport the goods. Your local Getinge representative will provide you such labels on request.
