Urgent Field Safety Notice

New warning in Instructions for Use for Ambu® aView™ 2 Advance

Ambu A/S - Single Registration (SRN): DK-MF-000001437

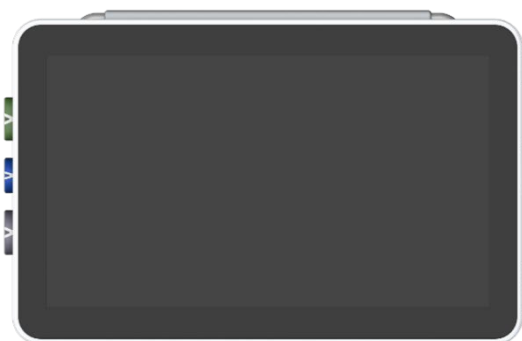
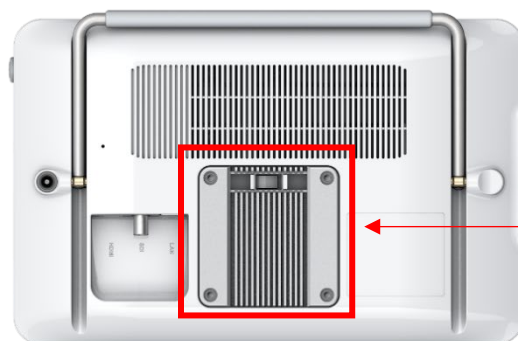
VESA interface for mounting on medical carts

Ambu has received information on two incidents where Ambu® aView™ 2 Advance caught fire when mounted on the VESA holder of the aCart™ Compact, due to the screws used entering the lithium-ion battery of the device. No patients or staff members were harmed during the incidents.

Upon conducting a comprehensive investigation, we have identified the root cause of these incidents. The fire hazard was a direct consequence of a battery short-circuit, which, in turn, was triggered by the use of excessively long screws to secure the device on the VESA holder. The longer screw lengths inadvertently penetrated the lithium-ion battery, leading to the fire hazard.

Use only M4 screws with the length of 14 – 16 mm when mounting Ambu aView 2 Advance on a VESA interface. Using longer screw lengths will penetrate the lithium-ion battery and result in a fire hazard and battery leakage which can cause severe burns, smoke inhalation and skin irritation. Using shorter screw lengths could result in unsecure device fastening.
